Effect Of Variation In Geotechnical Data On Stability Of Well Foundation

Yogita Gupta¹, Suneet Kaur², Nitin Dindorkar³

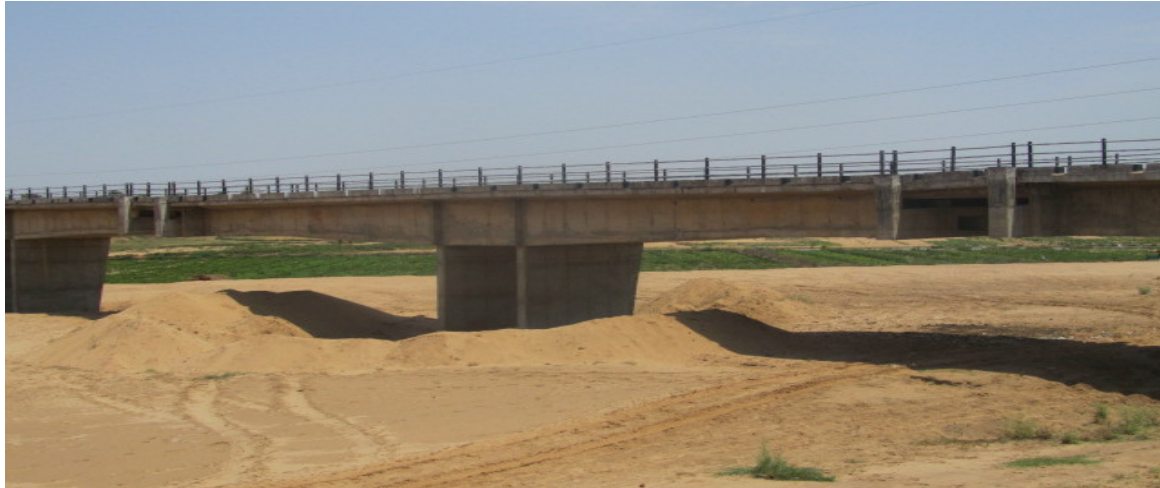
Photo no. 1 - settled pier P10

1. The bridge consists of rigid frame structure with two wall type Piers on well cap & small suspended span (solid slab) supported on Cantilever deck (PSC Box type) on both sides of pier. Wall type pier were rigidly connected with box over it (PSC Box type of deck) Figure1 & Figure 6.

2. The bridge when observed as a whole showed that out of 13 spans, the suspended spans (second and third suspended spans) supported on cantilever from pier unit p10 disturbed.

3. Affected second and third suspended span were critically observed. It is supported on the end of the cantilever span from pier unit P10. Cantilever span is prestressed concrete box span. The cantilever prestressed concrete deck rigidly connected with the two wall type piers unit P10 spaced at 4.5 m centre to centre and cantilevered on both sides (figure 6 & Figure1).

The newly constructed Bridge was submerged up to the top of deck during first monsoon and one of the well foundations have been settled. The maximum settlement of well no. 10 is 11 cm Figure 6. This may be due to weak soil at the founding level not capable of bearing the load or the calculated scour depth is inadequate.

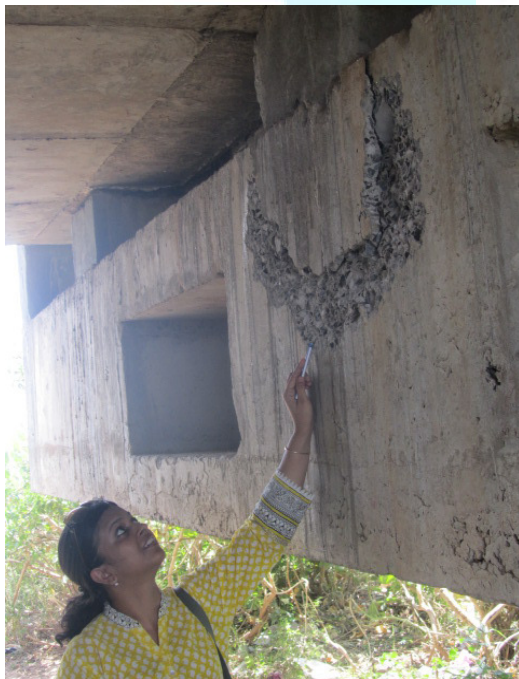
Photo no. 2 - Tip of cantilever span

6. Suspended span supported on cantilever is 3.7m solid slab type.
7. Three PTFE bearings are provided in the width at each end of suspended span (Figure2). To prevent displacement of the suspended span due to submergence two vertical RCC posts are erected at the end of box structure.

9. There are depressions and honey combs in the surface of concrete. A large chunk of concrete was found loosely placed on the surface of cantilever span Figure2. This was removed, the surface of concrete was not of proper quality.

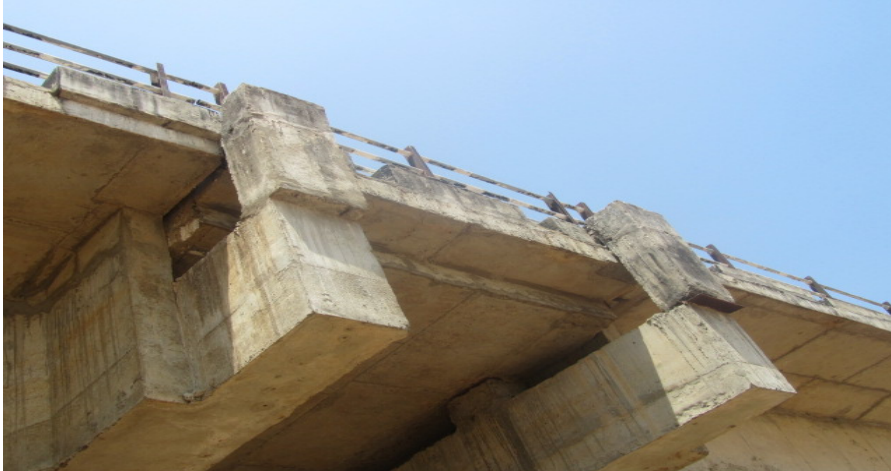
Photo no. 3 – Protection of suspended span

8. It was observed that the vertical post has come out 50 mm. beyond the end of the cross girder on which it is supporting (Figure3). This may be due to improper workmanship Figure3.

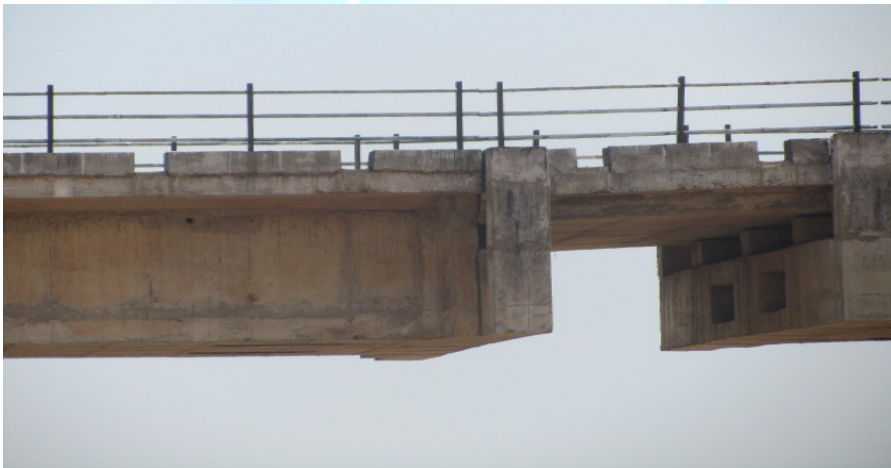
Photo no. 4 - Deflected suspended span on right side

4. Levels were taken at both the ends of second and third suspended span. For both the suspended span deflection was 11cm Figure 7, Figure 4 and 5.
5. As there were no difference in levels along the width of suspended span, tilting of well

can be ruled out and deflection of suspended span is due to settlement of substructure only.

This is unsafe and the well may settle on that account. Thus due to inadequate assessment of scour and the passive resistance the well is subjected to overstress and got settled by 11 cm (Figure4, 5 and 7).
