Case Study On Erosion Failure Of CFBC Boiler

Abstract

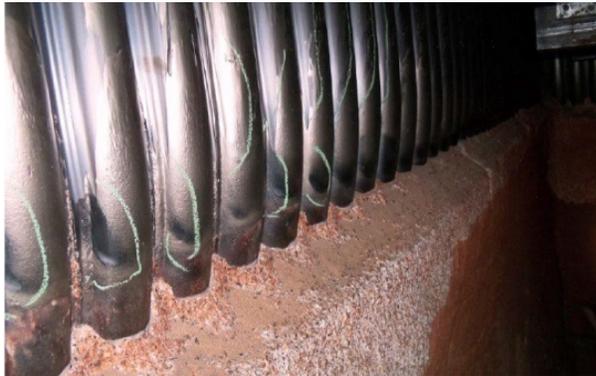
Due to overloading the erosion pattern has to be uniform. In all the rear wall tubes, where the dust slip is expected to be more both at 3 O and 9 O clock position gross erosion must be seen. In this installation localised spot erosion is seen. This can be due to the improper bond of the metal spray done at factory.

Fig 1 Shows erosion observe on kick off zone

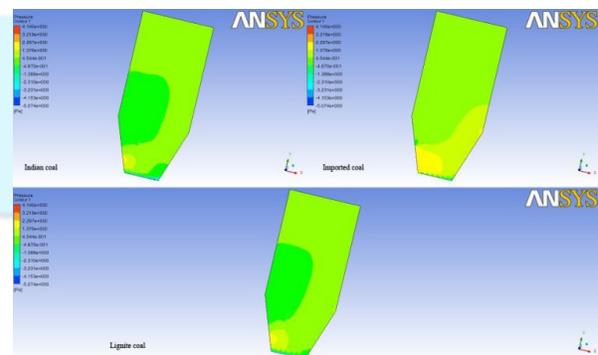
Fig 2 Shows Pressure distribution (Pa)

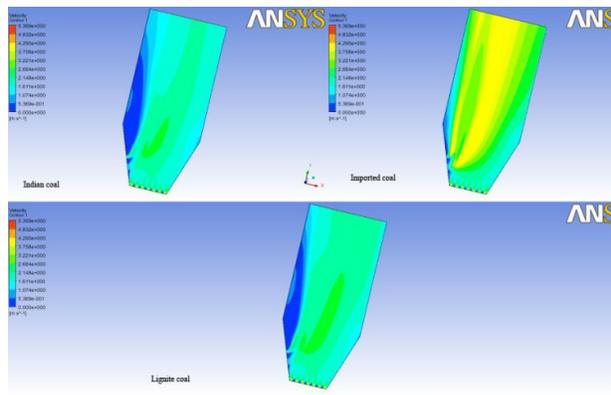
Fig 3 Shows Velocity distribution (Pa)

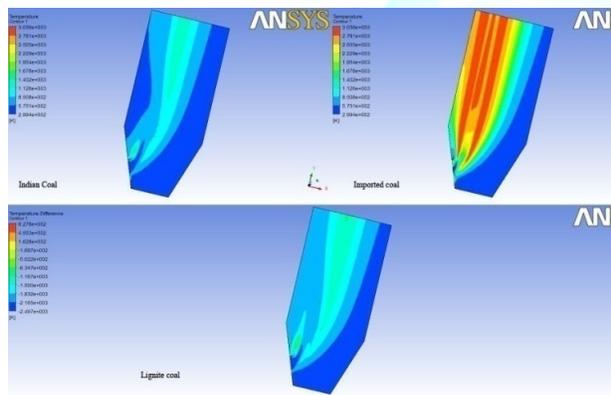
Fig 4. Shows Temperature distribution (Pa)
